**Flood Control Project Maintenance
Levee Inspections**

Maintenance Issue Types Only, Levee Inspection Report By Mile - Spring 2018

Lake County Watershed Protection District

Waterway	Bank	Unit Miles	Inspection Start/End	Inspector
Unit No. 01 Middle Creek	Left	3.35	04/12/2018 04/12/2018	Bob Duffey

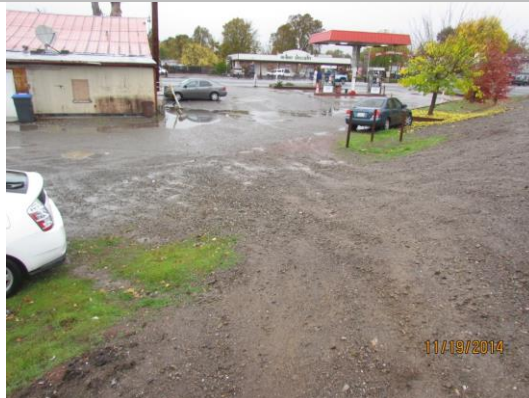
Photo 1 of 1 : SP_2018_NA0009_3_17_20180305_00011.jpg

LM Start	2.42	Rating **	M	Issue No.	17
LM End	2.42	Issue Type +	Ma	Location *	LS
Category	Earthen Levee			GPS Latitude/Longitude	
				Start	End
Item	Slope Stability			39.161802 °	39.161802 °
				-122.912020 °	-122.912020 °
DWR ID	DWR_NA0009_01_s_2013_17				
Comment Code					
S3 : Repair the levee slope damaged by vehicle traffic and prevent access where possible.					
Inspector Comment

View of the erosion caused by vehicle along the landside slope.

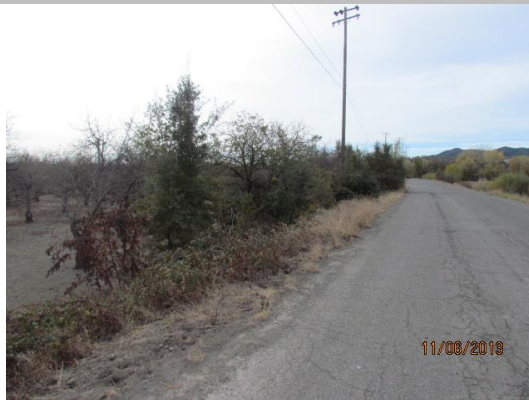
Photo 1 of 2 : SP_2018_NA0009_3_3_20180305_00001.jpg

LM Start	2.48	Rating **	U	Issue No.	3
LM End	2.55	Issue Type +	Ma	Location *	LS
Category	Earthen Levee			GPS Latitude/Longitude	
				Start	End
Item	Vegetation			39.161615 °	39.160804 °
				-122.911733 °	-122.912536 °
DWR ID	DWR_NA0009_01_s_2012_3				
Comment Code					
V2 : Remove the wild growth other than native grasses from the levee slopes.					
Inspector Comment

View of the vegetation along the landside slope.

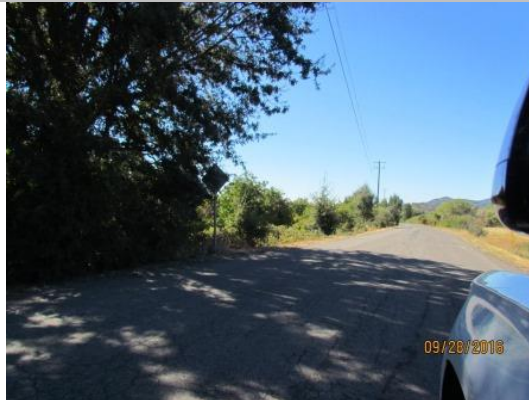
Photo 2 of 2 : SP_2018_NA0009_3_3_20180305_00002.jpg

LM Start	2.48	Rating **	U	Issue No.	3 (cont)
LM End	2.55	Issue Type +	Ma	Location *	LS

View of the vegetation along the landside slope.

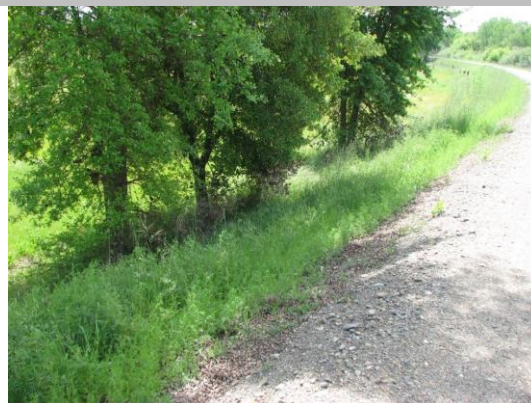
Photo 1 of 1 : SP_2018_NA0009_3_25_20180305_00015.jpg

LM Start	2.95	Rating **	M	Issue No.	25
LM End	2.95	Issue Type +	Ma	Location *	LS
Category	Earthen Levee			GPS Latitude/Longitude	
				Start	End
Item	Trim / Thin Trees			39.155301 °	39.155301 °
				-122.914633 °	-122.914633 °
DWR ID	DWR_NA0009_01_s_2016_25				
Comment Code					
T1 : Trim trees to at least five feet above ground level.					
Inspector Comment

Trim trees to 5' above levee slope (LS). 4/19/2016

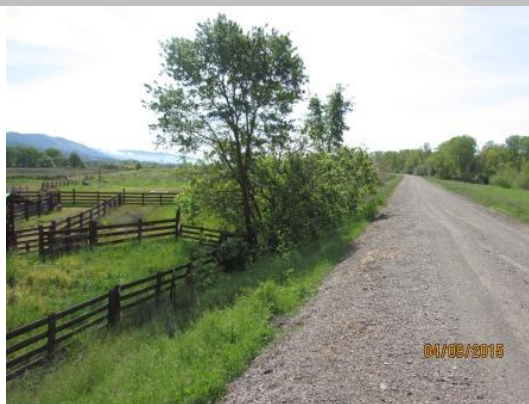
Photo 1 of 1 : SP_2018_NA0009_3_534_20180305_00021.jpg

LM Start	3.26	Rating **	M	Issue No.	534
LM End	3.26	Issue Type +	Ma	Location *	LS
Category	Earthen Levee			GPS Latitude/Longitude	
				Start	End
Item	Trim / Thin Trees			39.150957 °	39.150957 °
				-122.913504 °	-122.913504 °
DWR ID	DWR_NA0009_01_s_2015_534				
Comment Code					
T2 : Thin trees to allow visibility of the ground and room to flood fight.					
Inspector Comment

Remove the trees from the landside toe.

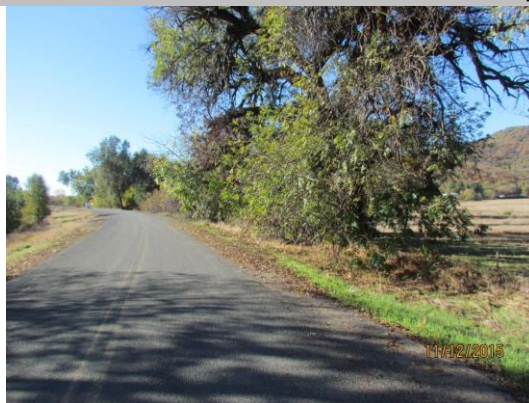
Photo 1 of 1 : SP_2018_NA0009_4_4_20180305_00004.jpg

LM Start	0.02	Rating **	M	Issue No.	4
LM End	0.14	Issue Type +	Ma	Location *	LS
Category	Earthen Levee			GPS Latitude/Longitude	
				Start	End
Item	Trim / Thin Trees			39.189540 °	39.187900 °
				-122.908065 °	-122.908655 °
DWR ID	DWR_NA0009_02_s _ 2013_4				
Comment Code					
T1 : Trim trees to at least five feet above ground level.					
Inspector Comment					
Trim the trees up 5 feet to allow visibility.

View of the overgrown trees at the landside toe.

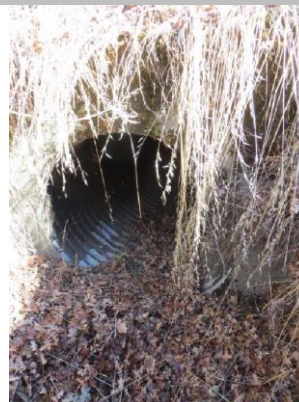
Photo 2 of 3 : UCIP_SP_2018_27066_50048.jpg

LM Start	0.14	Rating **	A/W	Issue No.	32
LM End	0.14	Issue Type +	Ma	Location *	
Category	Supplemental			GPS Latitude/Longitude	
				Start	End
Item	DWR UCIP LMA Responsibility			39.187919 °	39.187919 °
				-122.908631 °	-122.908631 °
DWR ID					
Comment Code					
Inspector Comment					
FS_ID:27066 DS_ID:21201 EP_NO: 11485 Repair Type: No Action Needed Crossing Status: Found UCIP Comments: FIELD_STRUCT_DESC: 42-inch corrugated metal drainage pipe through the levee, 8.5 feet below the crown. Flap gate on the waterside (WS). Concrete headwalls on both ends. (42-inch pipe [HLM 0.13] retained under Automatic Board Order (ABO) issued as Permit No. 11485, 1975 - John and Vivian Strickfaden). [Additional Reference(s): DWR Levee Log, 2005. USACE Sacramento O&M Manual 506.2, August 1961, (HLM 0.13)]. FS Date: 1/14/2014

Pipe and headwall visible at LS toe in drainage swale.

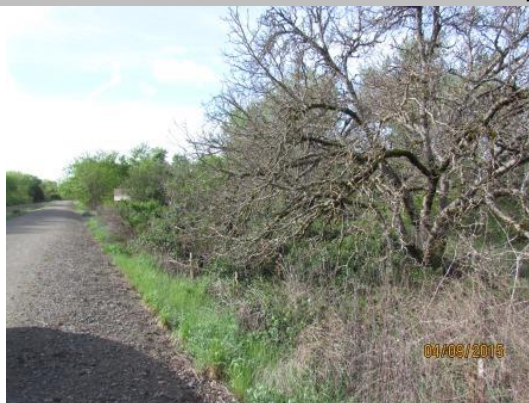
Photo 1 of 1 : SP_2018_NA0009_4_7_20180305_00005.jpg

LM Start	0.97	Rating **	M	Issue No.	7
LM End	0.98	Issue Type +	Ma	Location *	LS
Category	Earthen Levee			GPS Latitude/Longitude	
				Start	End
Item	Vegetation			39.177218 °	39.176992 °
				-122.913673 °	-122.913642 °
DWR ID	DWR_NA0009_02_s_2012_7				
Comment Code					
V2 : Remove the wild growth other than native grasses from the levee slopes.					
Inspector Comment

View of the vegetation at the landside toe.

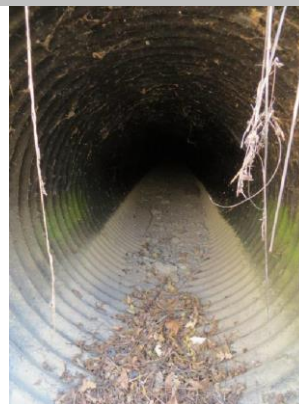
Photo 2 of 3 : UCIP_SP_2018_27583_51201.jpg

LM Start	1.03	Rating **	A/W	Issue No.	39
LM End	1.03	Issue Type +	Ma	Location *	
Category	Supplemental			GPS Latitude/Longitude	
				Start	End
Item	DWR UCIP LMA Responsibility			39.176366 °	39.176366 °
				-122.913509 °	-122.913509 °
DWR ID					
Comment Code					
Inspector Comment					
FS_ID:27583 DS_ID:21211 EP_NO: 11486 Repair Type: No Action Needed Crossing Status: Found UCIP Comments: FIELD_STRUCT_DESC: 36-inch corrugated metal drainage pipe through the levee, 7.3 feet below the crown. Flap gate on the waterside (WS) end. Concrete headwalls on both ends. Splash apron broken off on the WS end. (36-inch pipe [HLM 1.08] retained under Automatic Board Order (ABO) issued as Permit No. 11486, 1975 - Mary Truesdell). [Additional Reference(s): DWR Levee Log, 2005. USACE Sacramento O&M Manual 506.2, August 1961, (HLM 1.08) Drawing No. CC-4-4-29]. FS Date: 1/22/2014

Pipe as visible from LS toe.

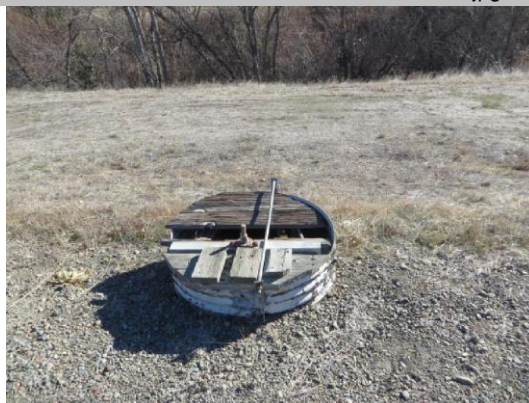
Photo 1 of 3 : UCIP_SP_2018_42994_51214.jpg

FS_ID:42994
DS_ID:21212
EP_NO: 11483
Repair Type: Non-Urgent
Crossing Status: Found
UCIP Comments: Pipe appears abandoned and if so, should be done so properly. Debris blocking flapgate at outlet.
FIELD_STRUCT_DESC: *ABANDONED* 30-inch corrugated metal drainage pipe through the levee, 17.8 feet below the crown. Slide gate in 44-inch corrugated metal riser unit on the waterside (WS) slope. Flap gate on the WS end at concrete headwall. 6-foot by 8-foot concrete sump at the landside (LS) toe. (30-inch pipe [HLM 1.22] retained under Automatic Board Order (ABO) issued as Permit No. 11483, 1975 - Edward M. and Mildred E. Seely). [Additional Reference(s): DWR Levee Log, 2005. USACE Sacramento O&M Manual 506.2, August 1961, (HLM 1.22)].
FS Date: 1/22/2014

Slide gate in 44-inch CMP riser on WS shoulder.

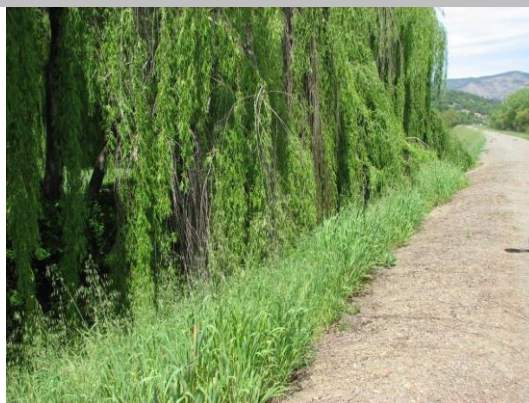
Photo 1 of 1 : SP_2018_NA0009_4_18_20180305_00009.jpg

LM Start	1.92	Rating **	M	Issue No.	18
LM End	1.92	Issue Type +	Ma	Location *	LS
Category	Earthen Levee			GPS Latitude/Longitude	
				Start	End
Item	Trim / Thin Trees			39.163912 °	39.163912 °
				-122.916695 °	-122.916695 °
DWR ID	DWR_NA0009_02_s_2016_18				
Comment Code					
T1 : Trim trees to at least five feet above ground level.					
Inspector Comment					
Trim willow trees.

View of the overgrown willow trees at the landside levee slope.

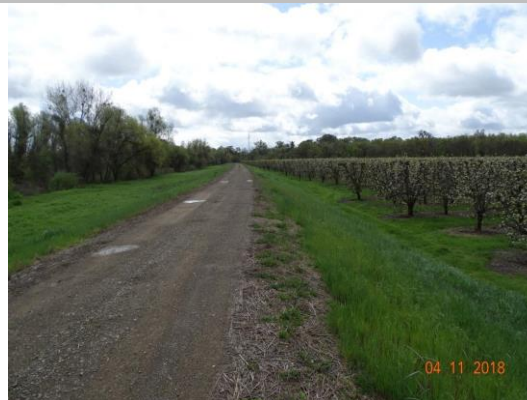
Photo 1 of 1 : SP_2018_NA0009_4_31_20180416_00051.jpg

LM Start	2.81	Rating **	A	Issue No.	31
LM End	2.81	Issue Type +	Ma	Location *	LS
Category	Earthen Levee			GPS Latitude/Longitude	
				Start	End
Item	Vegetation			39.151758 °	39.151758 °
				-122.915127 °	-122.915127 °
DWR ID	DWR_NA0009_02_s _ 2018_31				
Comment Code					
V1 : Control annual grass and weeds on the levee slopes and easements.					
Inspector Comment					
Native vegetation is well maintained on both slopes.

View of native vegetation on both slopes.

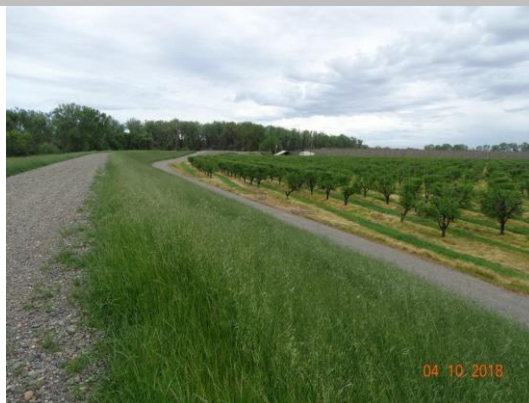
Photo 1 of 1 : SP_2018_NA0009_5_20_20180416_00042.jpg

LM Start	0.16	Rating **	A	Issue No.	20
LM End	0.16	Issue Type +	Ma	Location *	LS
Category	Earthen Levee			GPS Latitude/Longitude	
				Start	End
Item	Vegetation			39.149920 °	39.149920 °
				-122.915542 °	-122.915542 °
DWR ID	DWR_NA0009_03_s _ 2018_20				
Comment Code					
V1 : Control annual grass and weeds on the levee slopes and easements.					
Inspector Comment					
Native vegetation on both slopes will soon need management.

View of the native vegetation on both slopes.

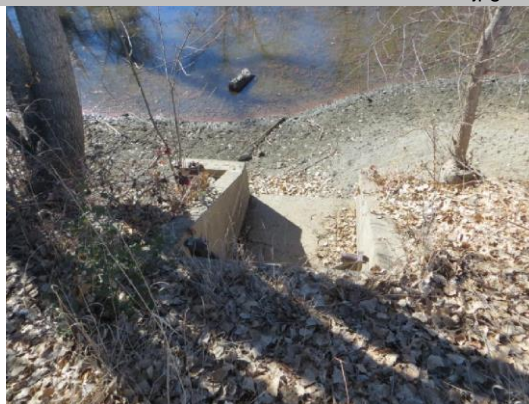
Photo 2 of 3 : UCIP_SP_2018_27863_51541.jpg

Concrete headwall and flapgate visible at WS berm.

Comment Code						
Inspector Comment						
FS_ID:27863 DS_ID:21217 EP_NO: 11492 Repair Type: Non-Urgent Crossing Status: Found UCIP Comments: Vegetation at inlet and wooden box failing at LS toe. FIELD_STRUCT_DESC: 42-inch corrugated metal drainage pipe through the levee, 12 feet below the crown. Flap gate on the waterside (WS) end. Concrete headwalls on both ends with a wooden retaining wall drop inlet at the landside (LS) toe. (42-inch pipe [HLM 0.55] retained under Automatic Board Order (ABO) issued as Permit No. 11492, 1975 - Dennis P. McCarthy). [Additional Reference(s): DWR Levee Log, 2005. USACE Sacramento O&M Manual 506.2, August 1961, (HLM 0.55) Drawing No. CC-4-4-29]. FS Date: 1/22/2014

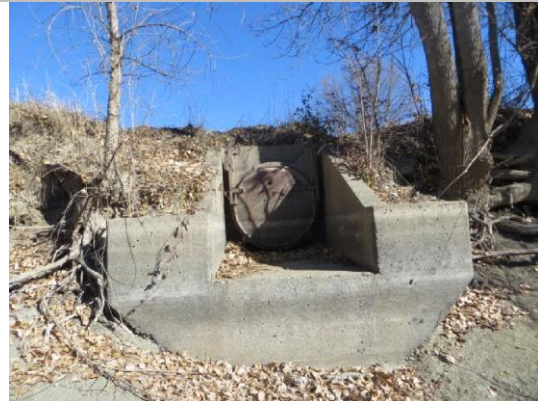
Photo 3 of 3 : UCIP_SP_2018_27863_51540.jpg

Concrete headwall and flapgate visible at WS berm.

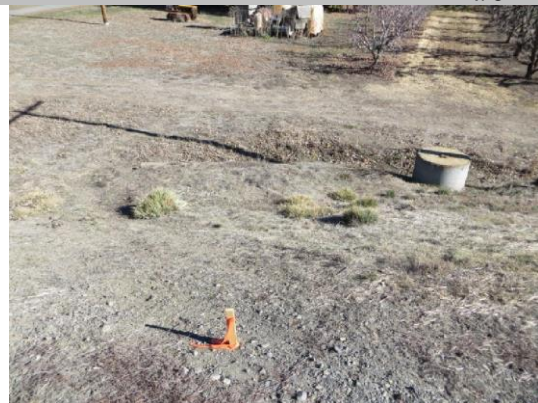
Photo 1 of 3 : UCIP_SP_2018_27892_51591.jpg

LM Start	0.77	Rating **	M	Issue No.	23
LM End	0.77	Issue Type +	Ma	Location *	
Category	Supplemental			GPS Latitude/Longitude	
				Start	End
Item	DWR UCIP LMA Responsibility			39.157759 °	39.157759 °
				-122.920301 °	-122.920301 °
DWR ID					
Comment Code					
Inspector Comment					
FS_ID:27892 DS_ID:21220 EP_NO: 11492 Repair Type: Non-Urgent Crossing Status: Found UCIP Comments: Some sediment buildup at inlet. FIELD_STRUCT_DESC: 24-inch corrugated metal drainage pipe through the levee, 10 feet below the crown. Flap gate on the waterside (WS) end. Concrete headwalls on both ends. Concrete spillway on the WS slope to bottom of channel. (24-inch pipe [HLM 0.79] retained under Automatic Board Order (ABO) issued as Permit No. 11492, 1975 - Dennis P. McCarthy). [Additional Reference(s): DWR Levee Log, 2005. USACE Sacramento O&M Manual 506.2, August 1961, (HLM 0.79)]. FS Date: 1/22/2014

Concrete headwall visible next to concrete standpipe on LS toe.

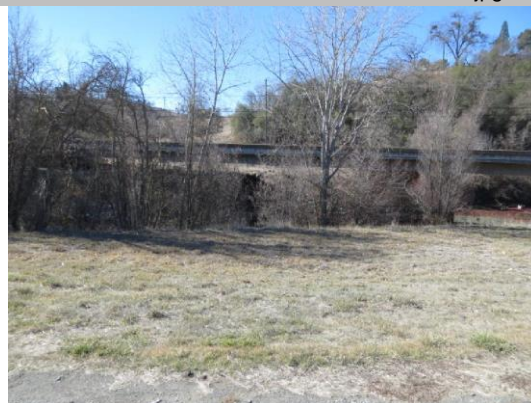
Photo 2 of 3 : UCIP_SP_2018_27892_51590.jpg

Concrete outfall visible off WS berm.

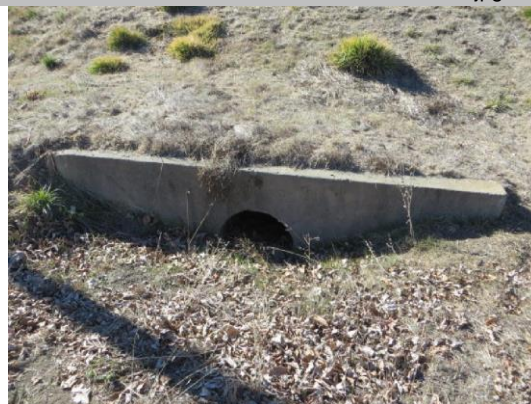
Photo 3 of 3 : UCIP_SP_2018_27892_51589.jpg

Concrete headwall visible at LS toe.

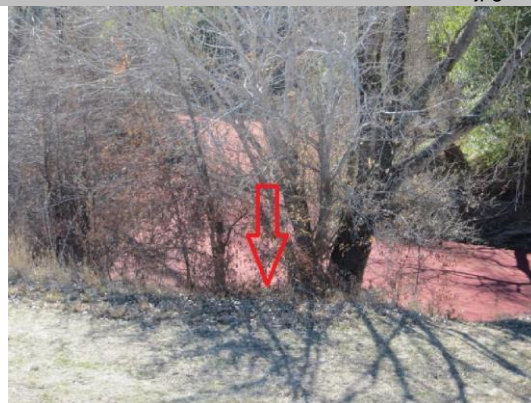
Photo 1 of 3 : UCIP_SP_2018_27894_51599.jpg

Comment Code					
Inspector Comment					
FS_ID:27894 DS_ID:21221 EP_NO: 11488 Repair Type: Non-Urgent Crossing Status: Found UCIP Comments: Concrete headwall on WS berm is being undermined. 2-foot of scour under headwall. FIELD_STRUCT_DESC: 42-inch corrugated metal drainage pipe through the levee, 16.5 feet below the crown. Flap gate on the waterside (WS) end. Concrete headwalls on both ends. (42-inch pipe [HLM 0.94] retained under Automatic Board Order (ABO) issued as Permit No. 11488, 1975 - Robert F. and Mary E. Wheeler). [Additional Reference(s): DWR Levee Log, 2005. USACE Sacramento O&M Manual 506.2, August 1961, (HLM 0.94)]. FS Date: 1/22/2014

Flapgate and headwall off WS toe.

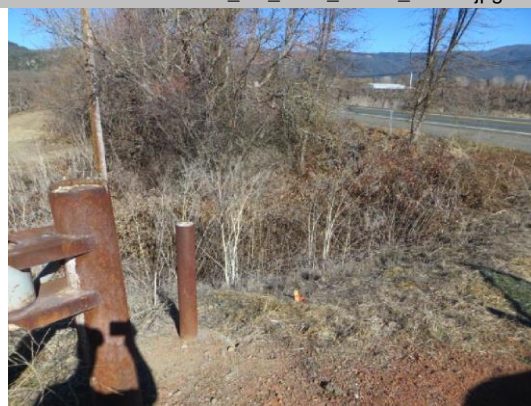
Photo 2 of 3 : UCIP_SP_2018_27894_51598.jpg

Concrete headwall on LS toe.

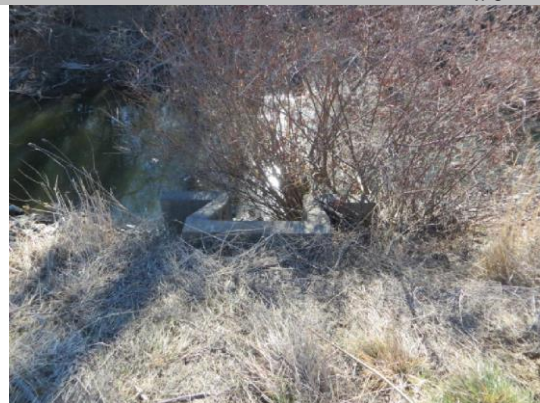
Photo 1 of 3 : UCIP_SP_2018_27943_51642.jpg

LM Start	0.99	Rating **	M	Issue No.	27
LM End	0.99	Issue Type +	Ma	Location *	
Category	Supplemental			GPS Latitude/Longitude	
				Start	End
Item	DWR UCIP LMA Responsibility			39.160117 °	39.160117 °
				-122.922144 °	-122.922144 °
DWR ID					
Comment Code					
Inspector Comment					
FS_ID:27943 DS_ID:21222 EP_NO: 11488 Repair Type: Non-Urgent Crossing Status: Found UCIP Comments: Some vegetation buildup at inlet and outlet. FIELD_STRUCT_DESC: 24-inch corrugated metal drainage pipe through the levee, 14 feet below the crown. Flap gate on the waterside (WS) end. Concrete headwalls on both ends. (24-inch pipe [HLM 1.01] retained under Automatic Board Order (ABO) issued as Permit No. 11488, 1975 - Robert F. and Mary E. Wheeler). [Additional Reference(s): DWR Levee Log, 2005. USACE Sacramento O&M Manual 506.2, August 1961, (HLM 1.01)]. FS Date: 1/22/2014

Concrete Headwall on WS berm.

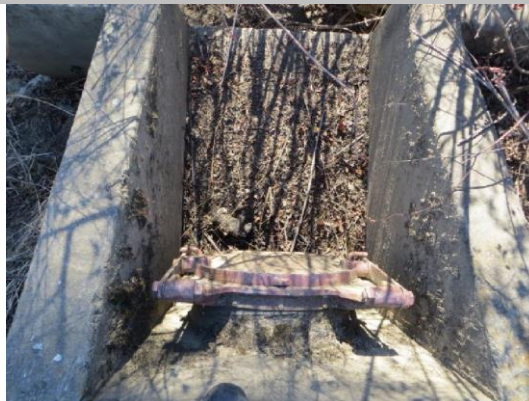
Photo 2 of 3 : UCIP_SP_2018_27943_51641.jpg

LM Start	0.99	Rating **	M	Issue No.	27 (cont)
LM End	0.99	Issue Type +	Ma	Location *	
Category	Supplemental			GPS Latitude/Longitude	
				Start	End
Item	DWR UCIP LMA Responsibility			39.160117°	39.160117°
				-122.922144°	-122.922144°
DWR ID					
Comment Code					
Inspector Comment					
FS_ID:27943 DS_ID:21222 EP_NO: 11488 Repair Type: Non-Urgent Crossing Status: Found UCIP Comments: Some vegetation buildup at inlet and outlet. FIELD_STRUCT_DESC: 24-inch corrugated metal drainage pipe through the levee, 14 feet below the crown. Flap gate on the waterside (WS) end. Concrete headwalls on both ends. (24-inch pipe [HLM 1.01] retained under Automatic Board Order (ABO) issued as Permit No. 11488, 1975 - Robert F. and Mary E. Wheeler). [Additional Reference(s): DWR Levee Log, 2005. USACE Sacramento O&M Manual 506.2, August 1961, (HLM 1.01)]. FS Date: 1/22/2014

Headwall and flapgate on WS berm.

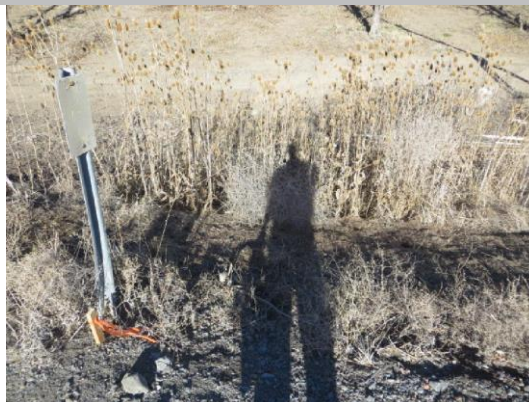
Photo 3 of 3 : UCIP_SP_2018_27943_51640.jpg

Pipe location marked on crown by flasher.

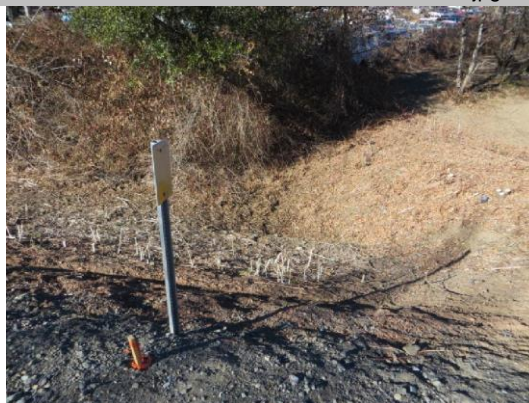
Photo 1 of 3 : UCIP_SP_2018_27944_51646.jpg

Comment Code					
Inspector Comment					
FS_ID:27944					
DS_ID:21223					
EP_NO: 11489					
Repair Type: Non-Urgent					
Crossing Status: Found					
UCIP Comments: Some sedimentation buildup at inlet and through pipe.					
FIELD_STRUCT_DESC: 24-inch corrugated metal drainage pipe					
through the levee, 12.5 feet below the crown. Flap gate on the					
waterside (WS) end. Concrete headwalls on both ends. (24-inch pipe					
[HLM 1.09] retained under Automatic Board Order (ABO) issued as					
Permit No. 11489, 1975 - Bank of Upper Lake). [Additional					
Reference(s): DWR Levee Log, 2005. USACE Sacramento O&M					
Manual 506.2, August 1961, (HLM 1.09)].					
FS Date: 1/22/2014

Flasher on crown marks pipe location.

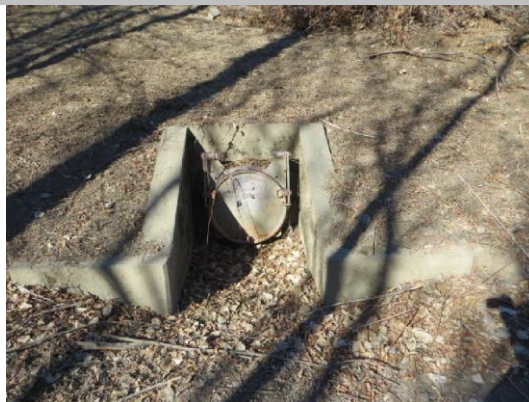
Photo 2 of 3 : UCIP_SP_2018_27944_51645.jpg

Flapgate and headwall visible on WS toe.

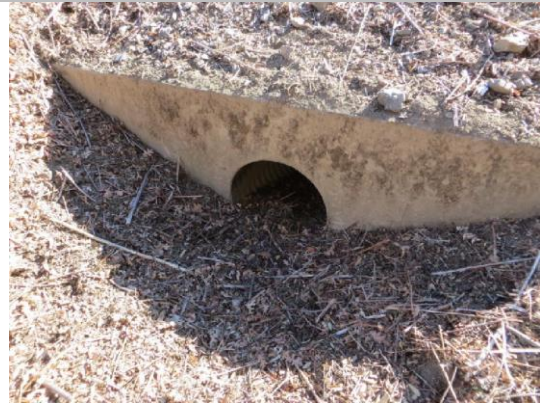
Photo 3 of 3 : UCIP_SP_2018_27944_51644.jpg

LM Start	1.07	Rating **	M	Issue No.	28 (cont)	
LM End	1.07	Issue Type +	Ma	Location *		
Category	Supplemental			GPS Latitude/Longitude		
				Start	End	
Item	DWR UCIP LMA Responsibility			39.159803 °	39.159803 °	
				-122.923501 °	-122.923501 °	
DWR ID						
Comment Code						
Inspector Comment						
FS_ID:27944 DS_ID:21223 EP_NO: 11489 Repair Type: Non-Urgent Crossing Status: Found UCIP Comments: Some sedimentation buildup at inlet and through pipe. FIELD_STRUCT_DESC: 24-inch corrugated metal drainage pipe through the levee, 12.5 feet below the crown. Flap gate on the waterside (WS) end. Concrete headwalls on both ends. (24-inch pipe [HLM 1.09] retained under Automatic Board Order (ABO) issued as Permit No. 11489, 1975 - Bank of Upper Lake). [Additional Reference(s): DWR Levee Log, 2005. USACE Sacramento O&M Manual 506.2, August 1961, (HLM 1.09)]. FS Date: 1/22/2014

Concrete headwall on LS toe.

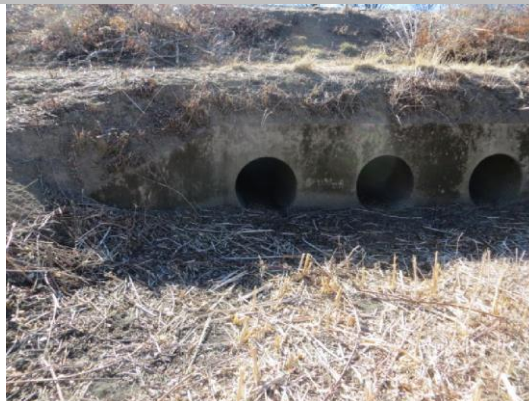
Photo 1 of 3 : UCIP_SP_2018_27963_51662.jpg

LM Start	1.23	Rating **	A/W	Issue No.	29
LM End	1.23	Issue Type +	Ma	Location *	
Category	Supplemental			GPS Latitude/Longitude	
				Start	End
Item	DWR UCIP LMA Responsibility			39.160359 °	39.160359 °
				-122.926188 °	-122.926188 °
DWR ID					
Comment Code					
Inspector Comment					
FS_ID:27963 DS_ID:21224 EP_NO: 11489 Repair Type: No Action Needed Crossing Status: Found UCIP Comments: FIELD_STRUCT_DESC: 1 of 4: 36-inch corrugated metal drainage pipe through the levee, 15.2 feet below the crown. Flap gate on the waterside (WS) end. Concrete headwalls on both ends. (four 36-inch pipes [HLM 1.25] retained under Automatic Board Order (ABO) issued as Permit No. 11489, 1975 - Bank of Upper Lake). [Additional Reference(s): DWR Levee Log, 2005. USACE Sacramento O&M Manual 506.2, August 1961, (HLM 1.25)]. FS Date: 1/22/2014

Concrete headwall on LS toe.

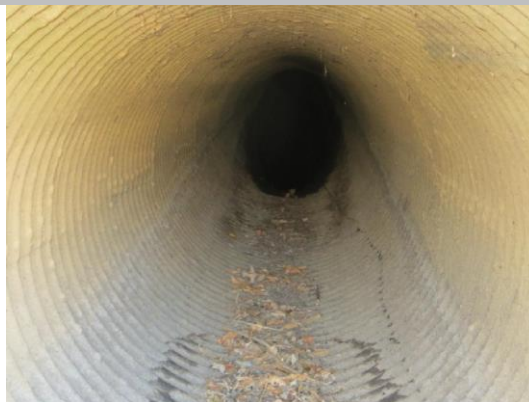
Photo 2 of 3 : UCIP_SP_2018_27963_51661.jpg

Pipe on LS toe.

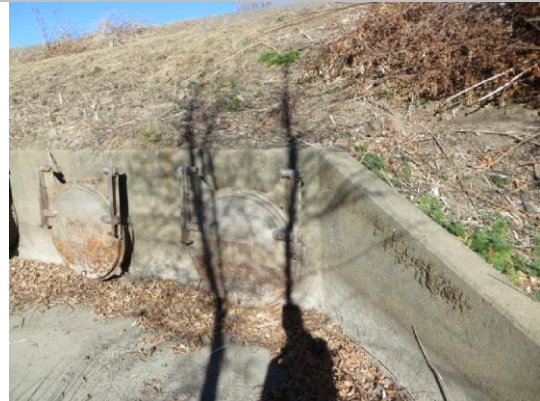
Photo 3 of 3 : UCIP_SP_2018_27963_51660.jpg

LM Start	1.23	Rating **	A/W	Issue No.	29 (cont)
LM End	1.23	Issue Type +	Ma	Location *	
Category	Supplemental			GPS Latitude/Longitude	
				Start	End
Item	DWR UCIP LMA Responsibility			39.160359 °	39.160359 °
				-122.926188 °	-122.926188 °
DWR ID					
Comment Code					
Inspector Comment					
FS_ID:27963 DS_ID:21224 EP_NO: 11489 Repair Type: No Action Needed Crossing Status: Found UCIP Comments: FIELD_STRUCT_DESC: 1 of 4: 36-inch corrugated metal drainage pipe through the levee, 15.2 feet below the crown. Flap gate on the waterside (WS) end. Concrete headwalls on both ends. (four 36-inch pipes [HLM 1.25] retained under Automatic Board Order (ABO) issued as Permit No. 11489, 1975 - Bank of Upper Lake). [Additional Reference(s): DWR Levee Log, 2005. USACE Sacramento O&M Manual 506.2, August 1961, (HLM 1.25)]. FS Date: 1/22/2014

Flapgate on headwall at WS toe.

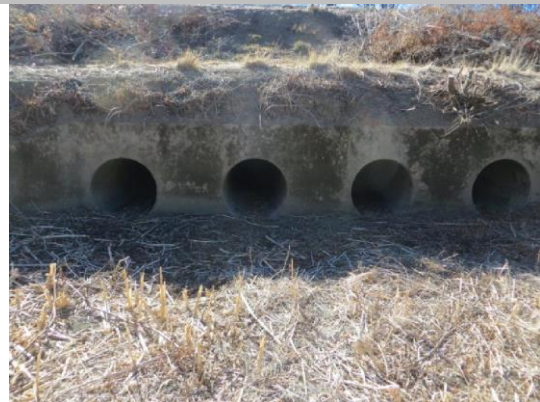
Photo 1 of 3 : UCIP_SP_2018_27964_51665.jpg

LM Start	1.23	Rating **	A/W	Issue No.	30	
LM End	1.23	Issue Type +	Ma	Location *		
Category	Supplemental			GPS Latitude/Longitude		
				Start	End	
Item	DWR UCIP LMA Responsibility			39.160369 °	39.160369 °	
				-122.926208 °	-122.926208 °	
DWR ID						
Comment Code						
Inspector Comment						
FS_ID:27964 DS_ID:21237 EP_NO: 11489 Repair Type: No Action Needed Crossing Status: Found UCIP Comments: FIELD_STRUCT_DESC: 2 of 4: 36-inch corrugated metal drainage pipe through the levee, 15.2 feet below the crown. Flap gate on the waterside (WS) end. Concrete headwalls on both ends. (four 36-inch pipes [HLM 1.25] retained under Automatic Board Order (ABO) issued as Permit No. 11489, 1975 - Bank of Upper Lake). [Additional Reference(s): DWR Levee Log, 2005. USACE Sacramento O&M Manual 506.2, August 1961, (HLM 1.25)]. FS Date: 1/22/2014

Pipe and headwall on LS toe.

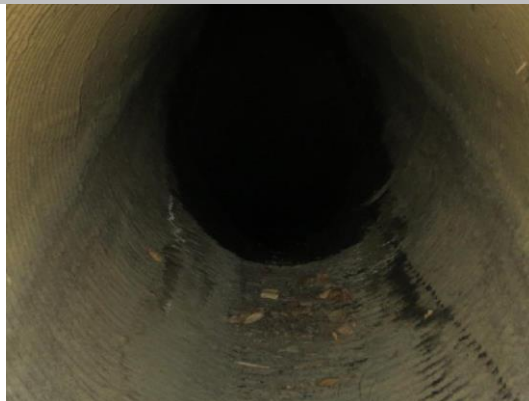
Photo 2 of 3 : UCIP_SP_2018_27964_51664.jpg

LM Start	1.23	Rating **	A/W	Issue No.	30 (cont)	
LM End	1.23	Issue Type +	Ma	Location *		
Category	Supplemental			GPS Latitude/Longitude		
				Start	End	
Item	DWR UCIP LMA Responsibility			39.160369 °	39.160369 °	
				-122.926208 °	-122.926208 °	
DWR ID						
Comment Code						
Inspector Comment						
FS_ID:27964 DS_ID:21237 EP_NO: 11489 Repair Type: No Action Needed Crossing Status: Found UCIP Comments: FIELD_STRUCT_DESC: 2 of 4: 36-inch corrugated metal drainage pipe through the levee, 15.2 feet below the crown. Flap gate on the waterside (WS) end. Concrete headwalls on both ends. (four 36-inch pipes [HLM 1.25] retained under Automatic Board Order (ABO) issued as Permit No. 11489, 1975 - Bank of Upper Lake). [Additional Reference(s): DWR Levee Log, 2005. USACE Sacramento O&M Manual 506.2, August 1961, (HLM 1.25)]. FS Date: 1/22/2014

Pipe from LS toe.

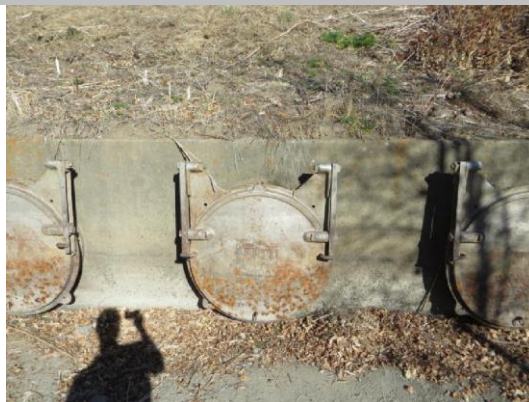
Photo 3 of 3 : UCIP_SP_2018_27964_51663.jpg

Flapgate and headwall on WS toe.

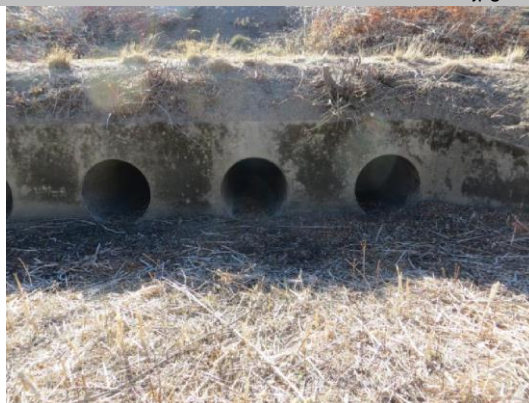
Photo 1 of 3 : UCIP_SP_2018_27965_51668.jpg

LM Start	1.24	Rating **	A/W	Issue No.	31
LM End	1.24	Issue Type +	Ma	Location *	
Category	Supplemental			GPS Latitude/Longitude	
				Start	End
Item	DWR UCIP LMA Responsibility			39.160377 °	39.160377 °
				-122.926223 °	-122.926223 °
DWR ID					
Comment Code					
Inspector Comment					
FS_ID:27965 DS_ID:21238 EP_NO: 11489 Repair Type: No Action Needed Crossing Status: Found UCIP Comments: FIELD_STRUCT_DESC: 3 of 4: 36-inch corrugated metal drainage pipe through the levee, 15.2 feet below the crown. Flap gate on the waterside (WS) end. Concrete headwalls on both ends. (four 36-inch pipes [HLM 1.25] retained under Automatic Board Order (ABO) issued as Permit No. 11489, 1975 - Bank of Upper Lake). [Additional Reference(s): DWR Levee Log, 2005. USACE Sacramento O&M Manual 506.2, August 1961, (HLM 1.25)]. FS Date: 1/22/2014

Pipe and concrete headwall on LS toe.

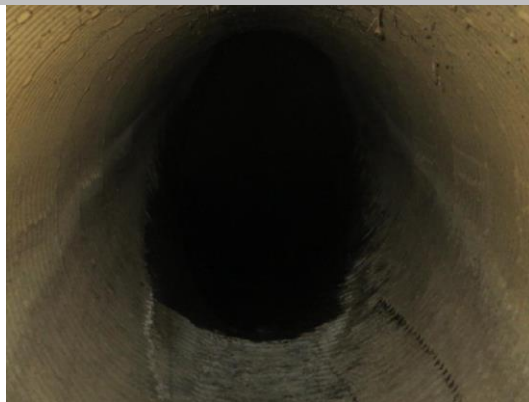
Photo 2 of 3 : UCIP_SP_2018_27965_51667.jpg

Pipe from LS toe.

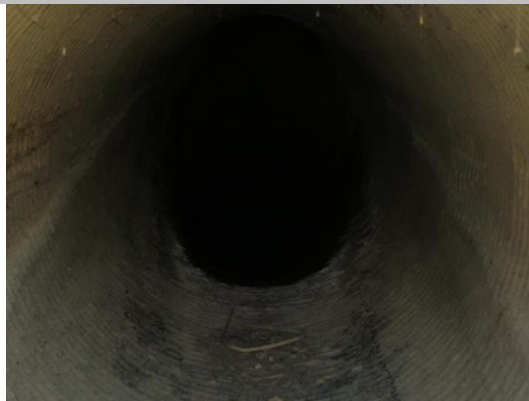
Photo 2 of 3 : UCIP_SP_2018_27967_51670.jpg

LM Start	1.24	Rating **	A/W	Issue No.	32 (cont)	
LM End	1.24	Issue Type +	Ma	Location *		
Category	Supplemental			GPS Latitude/Longitude		
				Start	End	
Item	DWR UCIP LMA Responsibility			39.160386 °	39.160386 °	
				-122.926239 °	-122.926239 °	
DWR ID						
Comment Code						
Inspector Comment						
FS_ID:27967 DS_ID:21239 EP_NO: 11489 Repair Type: No Action Needed Crossing Status: Found UCIP Comments: FIELD_STRUCT_DESC: 4 of 4: 36-inch corrugated metal drainage pipe through the levee, 15.2 feet below the crown. Flap gate on the waterside (WS) end. Concrete headwalls on both ends. (four 36-inch pipes [HLM 1.25] retained under Automatic Board Order (ABO) issued as Permit No. 11489, 1975 - Bank of Upper Lake). [Additional Reference(s): DWR Levee Log, 2005. USACE Sacramento O&M Manual 506.2, August 1961, (HLM 1.25)]. FS Date: 1/22/2014

Pipe from LS toe.

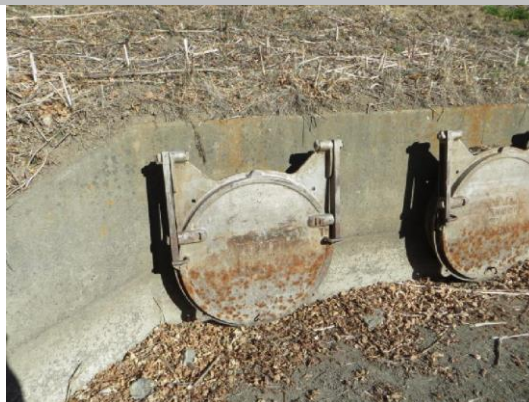
Photo 3 of 3 : UCIP_SP_2018_27967_51669.jpg

Flapgate on concrete headwall on WS toe.

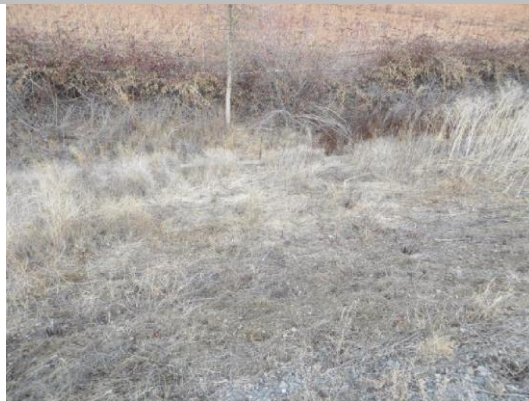
Photo 1 of 3 : UCIP_SP_2018_26947_49793.jpg

LM Start	0.14	Rating **	A/W	Issue No.	18
LM End	0.14	Issue Type +	Ma	Location *	
Category	Supplemental			GPS Latitude/Longitude	
				Start	End
Item	DWR UCIP LMA Responsibility			39.176422 °	39.176422 °
				-122.909978 °	-122.909978 °
DWR ID					
Comment Code					
Inspector Comment					
FS_ID:26947 DS_ID:21236 EP_NO: 11499 Repair Type: No Action Needed Crossing Status: Found UCIP Comments: FIELD_STRUCT_DESC: 1 of 2: 42-inch corrugated metal drainage pipe through the levee, 12 feet below the crown. Flap gate on the waterside (WS) end. Concrete headwalls on both ends. (two 42-inch pipes [HLM 0.14] retained under Automatic Board Order (ABO) issued as Permit No. 11499, 1975 - Howard D. and Eunice A. Norton). [Additional Reference(s): DWR Levee Log, 2005. USACE Sacramento O&M Manual 506.2, August 1961, (HLM 0.14)]. FS Date: 1/9/2014

Concrete headwall visible on LS toe.

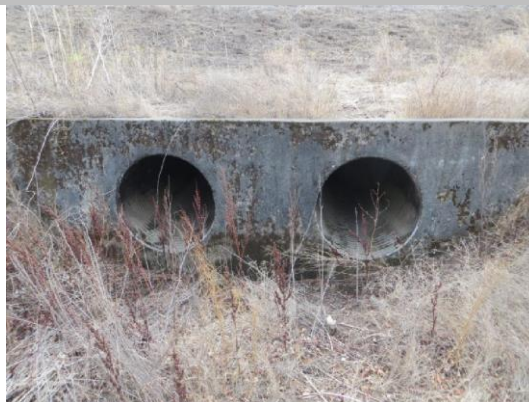
Photo 2 of 3 : UCIP_SP_2018_26947_49792.jpg

Concrete headwall visible on LS toe.

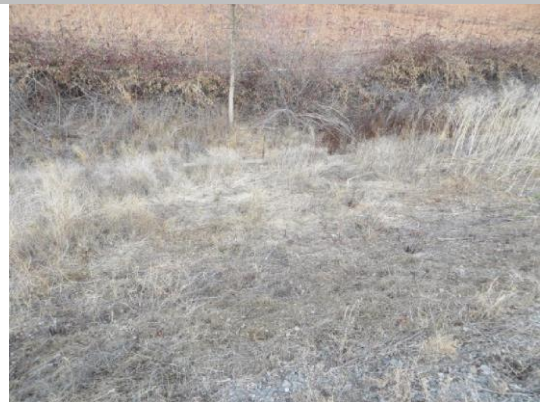
Photo 1 of 3 : UCIP_SP_2018_26948_49797.jpg

LM Start	0.14	Rating **	A/W	Issue No.	19	
LM End	0.14	Issue Type +	Ma	Location *		
Category	Supplemental			GPS Latitude/Longitude		
				Start	End	
Item	DWR UCIP LMA Responsibility			39.176419 °	39.176419 °	
				-122.909954 °	-122.909954 °	
DWR ID						
Comment Code						
Inspector Comment						
FS_ID:26948 DS_ID:21225 EP_NO: 11499 Repair Type: No Action Needed Crossing Status: Found UCIP Comments: FIELD_STRUCT_DESC: 2 of 2: 42-inch corrugated metal drainage pipe through the levee, 12 feet below the crown. Flap gate on the waterside (WS) end. Concrete headwalls on both ends. (two 42-inch pipes [HLM 0.14] retained under Automatic Board Order (ABO) issued as Permit No. 11499, 1975 - Howard D. and Eunice A. Norton). [Additional Reference(s): DWR Levee Log, 2005. USACE Sacramento O&M Manual 506.2, August 1961, (HLM 0.14)]. FS Date: 1/9/2014

Concrete headwall and inlet visible on LS toe.

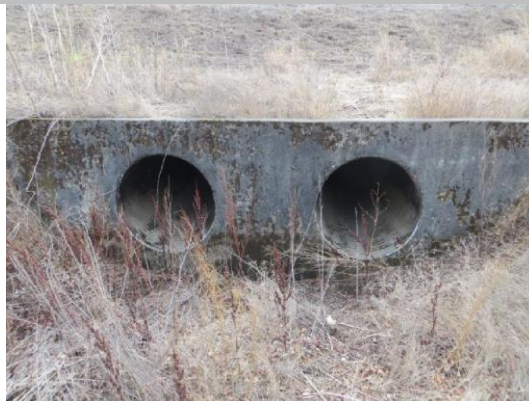
Photo 2 of 3 : UCIP_SP_2018_26948_49796.jpg

LM Start	0.14	Rating **	A/W	Issue No.	19 (cont)
LM End	0.14	Issue Type +	Ma	Location *	
Category	Supplemental			GPS Latitude/Longitude	
				Start	End
Item	DWR UCIP LMA Responsibility			39.176419 °	39.176419 °
				-122.909954 °	-122.909954 °
DWR ID					
Comment Code					
Inspector Comment					
FS_ID:26948 DS_ID:21225 EP_NO: 11499 Repair Type: No Action Needed Crossing Status: Found UCIP Comments: FIELD_STRUCT_DESC: 2 of 2: 42-inch corrugated metal drainage pipe through the levee, 12 feet below the crown. Flap gate on the waterside (WS) end. Concrete headwalls on both ends. (two 42-inch pipes [HLM 0.14] retained under Automatic Board Order (ABO) issued as Permit No. 11499, 1975 - Howard D. and Eunice A. Norton). [Additional Reference(s): DWR Levee Log, 2005. USACE Sacramento O&M Manual 506.2, August 1961, (HLM 0.14). FS Date: 1/9/2014

Concrete headwall and inlet visible on LS toe.

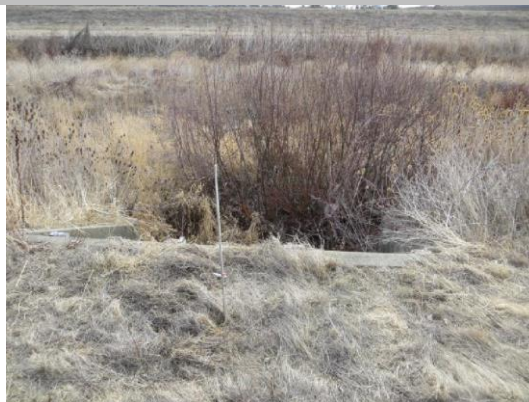
Photo 3 of 3 : UCIP_SP_2018_26948_49795.jpg

Concrete headwall visible on toe of WS berm.

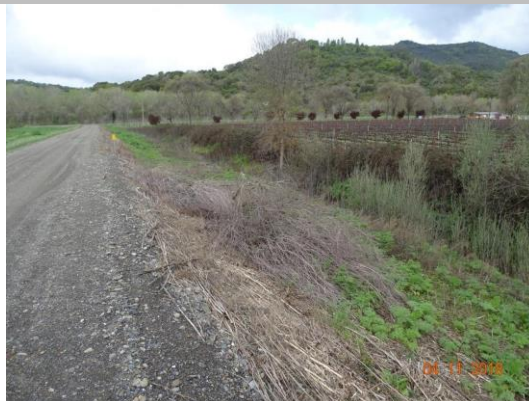
Photo 1 of 1 : SP_2018_NA0009_6_17_20180416_00026.jpg

LM Start	0.15	Rating **	M	Issue No.	17
LM End	0.15	Issue Type +	Ma	Location *	LS
Category	Earthen Levee			GPS Latitude/Longitude	
				Start	End
Item	Encroachments			39.176420 °	39.176420 °
				-122.909693 °	-122.909693 °
DWR ID	DWR_NA0009_04_s _ 2018_17				
Comment Code					
TR : Tree or limb					
Inspector Comment					
Removed the trees from the landside slope.

View of the tree along the landside slope.

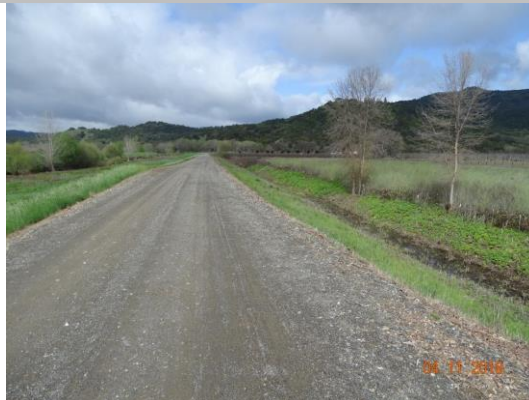
Photo 1 of 1 : SP_2018_NA0009_6_16_20180416_00025.jpg

LM Start	0.41	Rating **	A	Issue No.	16
LM End	0.41	Issue Type +	Ma	Location *	LS
Category	Earthen Levee			GPS Latitude/Longitude	
				Start	End
Item	Vegetation			39.176447 °	39.176447 °
				-122.904838 °	-122.904838 °
DWR ID	DWR_NA0009_04_s _ 2018_16				
Comment Code					
V1 : Control annual grass and weeds on the levee slopes and easements.					
Inspector Comment					
Native grasses on both slopes are adequately maintained.

View of the native grasses along both slopes.

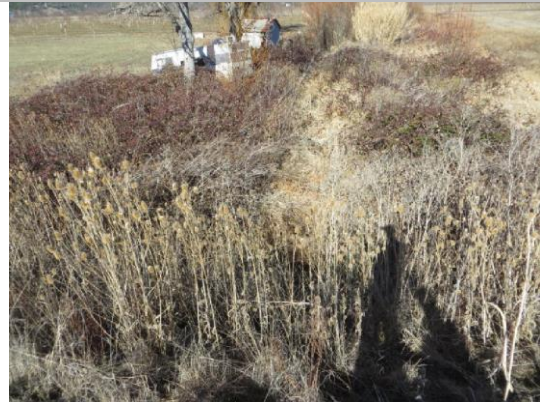
Photo 1 of 3 : UCIP_SP_2018_51472_49754.jpg

Comment Code						
Inspector Comment						
FS_ID:51472 DS_ID:21227 EP_NO: 11501 Repair Type: Urgent Crossing Status: Found UCIP Comments: 11/30/2016 Clover Creek has significant sediment build up that blocks the outlet. Crossing is still in use to drain water from LS to WS according to LMA representative, Scott Webb. (O. Magana - DWR UCIP)01/09/2014 Pipe rusted through at connection to flapgate. Good indication pipe may need replacement. Video inspection recommended. (W. Wylie - DWR UCIP) FIELD_STRUCT_DESC: 24-inch corrugated metal (CM) drainage pipe through the levee, 13.8 feet below the crown. Flap gate is located on the waterside (WS) end. Concrete headwalls located on both the WS and landside (LS) ends. (24-inch pipe [HLM 0.77] was retained under Automatic Board Order (ABO) issued as Permit No. 11501, 1975 - Sisevich). [Additional Reference(s): DWR Levee Log, 2005. USACE Sacramento O&M Manual Unit 506.2, August 1961, (HLM 0.77)]. FS Date: 11/30/2016

Drainage canal at inlet on LS toe.

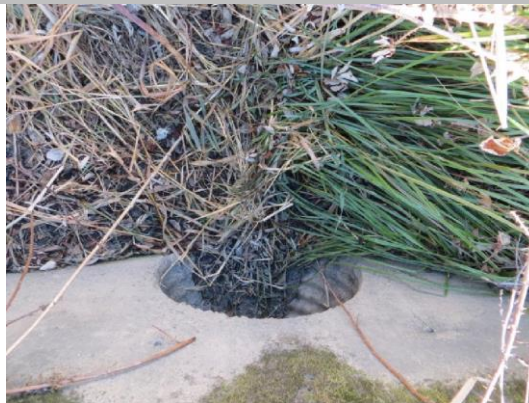
Photo 2 of 3 : UCIP_SP_2018_51472_49753.jpg

FS_ID:51472
DS_ID:21227
EP_NO: 11501
Repair Type: Urgent
Crossing Status: Found
UCIP Comments: 11/30/2016 Clover Creek has significant sediment build up that blocks the outlet. Crossing is still in use to drain water from LS to WS according to LMA representative, Scott Webb. (O. Magana - DWR UCIP)01/09/2014 Pipe rusted through at connection to flapgate. Good indication pipe may need replacement. Video inspection recommended. (W. Wylie - DWR UCIP)
FIELD_STRUCT_DESC: 24-inch corrugated metal (CM) drainage pipe through the levee, 13.8 feet below the crown. Flap gate is located on the waterside (WS) end. Concrete headwalls located on both the WS and landside (LS) ends. (24-inch pipe [HLM 0.77] was retained under Automatic Board Order (ABO) issued as Permit No. 11501, 1975 - Sisevich). [Additional Reference(s): DWR Levee Log, 2005. USACE Sacramento O&M Manual Unit 506.2, August 1961, (HLM 0.77)].
FS Date: 11/30/2016

Pipe and concrete headwall visible in drainage channel on LS toe.

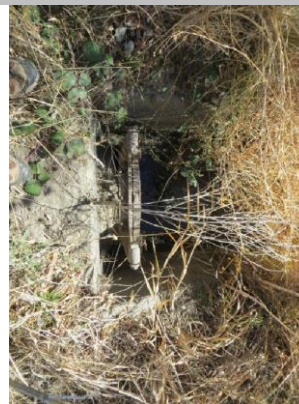
Photo 3 of 3 : UCIP_SP_2018_51472_49752.jpg

Flapgate at concrete headwall on WS toe.

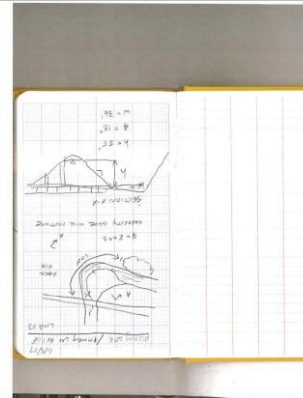
Photo 1 of 2 : LEVAL_SP_2018_18_1398.jpg

LM Start	0.99	Rating **	A/W	Issue No.	11
LM End	1.00	Issue Type +	Ma	Location *	
Category	Supplemental			GPS Latitude/Longitude	
				Start	End
Item	2017 Storm Damage			39.179715 °	39.179916 °
				-122.896926 °	-122.896970 °
DWR ID	DWR_NA0009_04_f_2017_11				
Comment Code					
Inspector Comment					
Levee Evaluation Comments					
Description:					
Site ID No:18					
Site Designation:LMA-3					
Repair Type: Erosion					
Rating:Critical					
Field Date:6/5/2017					
Notes: Erosion begins at the edge of the patrol road. Slope is covered in loose gravel, washes out every high water season.

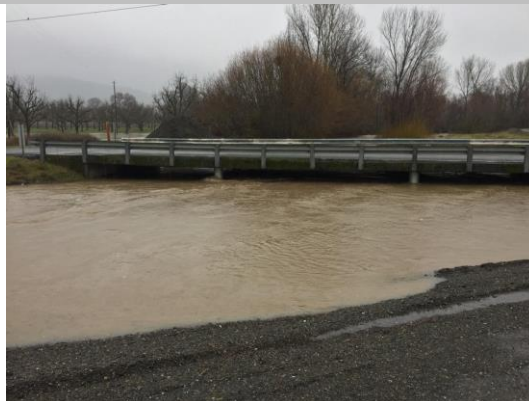
Photo 2 of 2 : LEVAL_SP_2018_18_335.jpg

LM Start	0.99	Rating **	A/W	Issue No.	11 (cont)	
LM End	1.00	Issue Type +	Ma	Location *		
Category	Supplemental			GPS Latitude/Longitude		
				Start		End
Item	2017 Storm Damage			39.179715 °		39.179916 °
				-122.896926 °		-122.896970 °
DWR ID	DWR_NA0009_04_f_2017_11					
Comment Code						
Inspector Comment						
Levee Evaluation Comments						
Description:						
Site ID No:18						
Site Designation:LMA-3						
Repair Type: Erosion						
Rating:Critical						
Field Date:6/5/2017						
Notes: Erosion begins at the edge of the patrol road. Slope is covered in loose gravel, washes out every high water season.

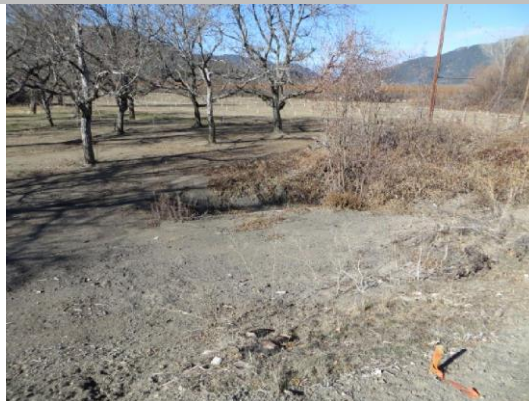
Photo 1 of 3 : UCIP_SP_2018_26924_49762.jpg

LM Start	1.19	Rating **	A/W	Issue No.	22	
LM End	1.19	Issue Type +	Ma	Location *		
Category	Supplemental			GPS Latitude/Longitude		
				Start	End	
Item	DWR UCIP LMA Responsibility			39.182079 °	39.182079 °	
				-122.895038 °	-122.895038 °	
DWR ID						
Comment Code						
Inspector Comment						
FS_ID:26924 DS_ID:21228 EP_NO: 11496 Repair Type: No Action Needed Crossing Status: Found UCIP Comments: FIELD_STRUCT_DESC: 42-inch corrugated metal drainage pipe through the levee, 8 feet below the crown. Flap gate on the waterside (WS) end. Concrete headwalls on both ends. (24-inch pipes [HLM 1.21] retained under Automatic Board Order (ABO) issued as Permit No. 11496, 1975 - Earl Foutch). [Additional Reference(s): DWR Levee Log, 2005. USACE Sacramento O&M Manual 506.2, August 1961, (HLM 1.21)]. FS Date: 1/9/2014

Drainpipe visible at LS toe.

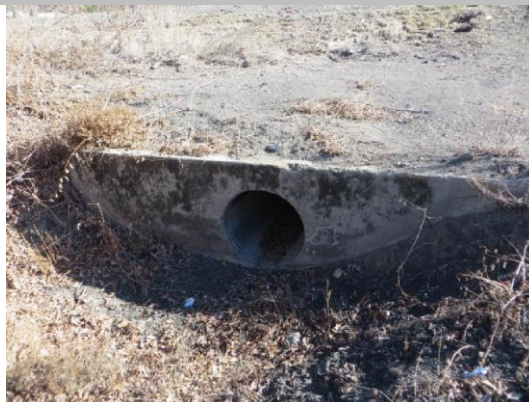
Photo 2 of 3 : UCIP_SP_2018_26924_49761.jpg

Concrete headwall and drainpipe visible at LS toe.

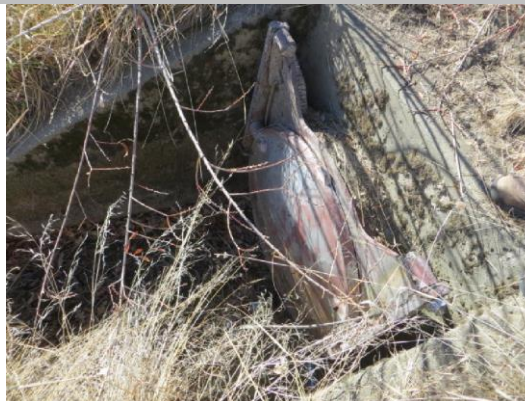
Photo 3 of 3 : UCIP_SP_2018_26924_49760.jpg

LM Start	1.19	Rating **	A/W	Issue No.	22 (cont)	
LM End	1.19	Issue Type +	Ma	Location *		
Category	Supplemental			GPS Latitude/Longitude		
				Start	End	
Item	DWR UCIP LMA Responsibility			39.182079 °	39.182079 °	
				-122.895038 °	-122.895038 °	
DWR ID						
Comment Code						
Inspector Comment						
FS_ID:26924 DS_ID:21228 EP_NO: 11496 Repair Type: No Action Needed Crossing Status: Found UCIP Comments: FIELD_STRUCT_DESC: 42-inch corrugated metal drainage pipe through the levee, 8 feet below the crown. Flap gate on the waterside (WS) end. Concrete headwalls on both ends. (24-inch pipes [HLM 1.21] retained under Automatic Board Order (ABO) issued as Permit No. 11496, 1975 - Earl Foutch). [Additional Reference(s): DWR Levee Log, 2005. USACE Sacramento O&M Manual 506.2, August 1961, (HLM 1.21)]. FS Date: 1/9/2014

Concrete headwall visible off WS berm.

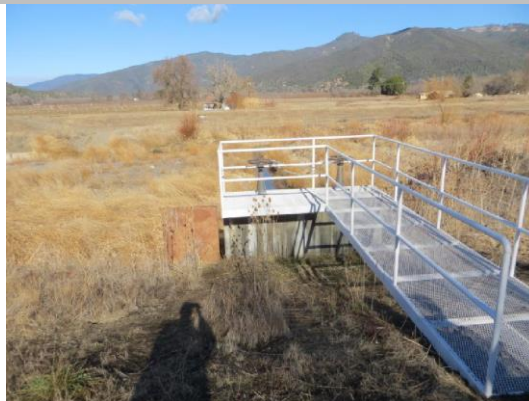
Photo 1 of 3 : UCIP_SP_2018_26891_49682.jpg

FS_ID:26891
DS_ID:21234
EP_NO: 11507
Repair Type: Non-Urgent
Crossing Status: Found
UCIP Comments: 10/27/2017 This structure is inspected annually under the Structure and Channel Summer Inspection (part of the Levee Inspection Program) conducted by the DWR Flood Project Integrity and Inspection Branch (FPIIB). (DWR UCIP - O. Magana)
Some sediment buildup on LS toe.
FIELD_STRUCT_DESC: [Clover Creek Diversion Structure] 2 of 6: 36-inch corrugated metal drainage pipe through the levee, 12 feet below the crown. Slide gate on the waterside (WS) end. Steel walkway on the WS slope to slide gate. Concrete headwalls on both ends. (six 36-inch pipes and structure [HLM 0.3] retained under Automatic Board Order (ABO) issued as Permit No. 11507, 1975 - Lake County Flood Control and Water Conservation District). [Additional Reference(s): DWR Levee Log, 2005. USACE Sacramento O&M Manual 506, Part 2, August 1961, (HLM 0.31)].

Slide gate on steel walkway at WS toe.

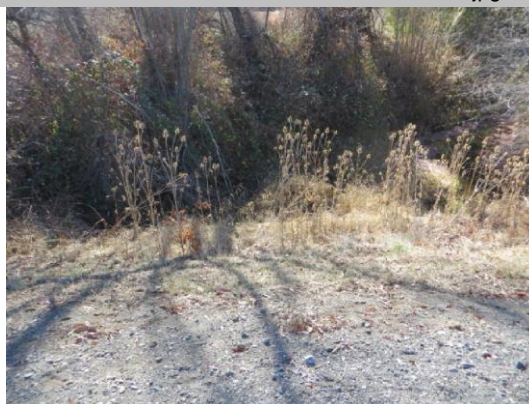
Photo 2 of 3 : UCIP_SP_2018_26891_49681.jpg

Outlet visible at concrete headwall on LS toe.

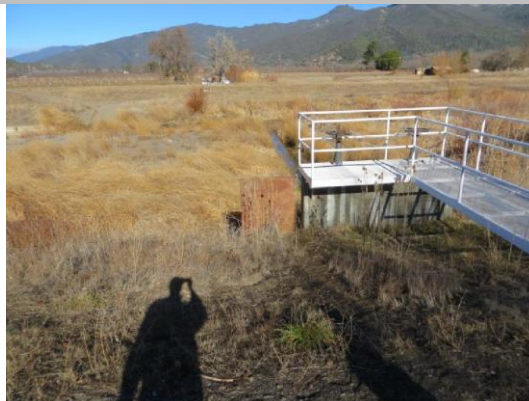
Photo 1 of 3 : UCIP_SP_2018_26888_49666.jpg

FS_ID:26888
DS_ID:21233
EP_NO: 11507
Repair Type: Non-Urgent
Crossing Status: Found
UCIP Comments: 10/27/2017 This structure is inspected annually under the Structure and Channel Summer Inspection (part of the Levee Inspection Program) conducted by the DWR Flood Project Integrity and Inspection Branch (FPIIB). (DWR UCIP - O. Magana)
Some sediment buildup at outlet on LS toe.
FIELD_STRUCT_DESC: [Clover Creek Diversion Structure] 3 of 6: 36-inch corrugated metal drainage pipe through the levee, 12 feet below the crown. Concrete headwall on both ends. Steel slide gate plate blocks inlet on the waterside (WS) toe. (six 36-inch pipes and structure [HLM 0.3] retained under Automatic Board Order (ABO) issued as Permit No. 11507, 1975 - Lake County Flood Control and Water Conservation District). [Additional Reference(s): DWR Levee Log, 2005. USACE Sacramento O&M Manual 506, Part 2, August 1961, (HLM 0.31)].

Steel slide gate visible at concrete headwall on WS toe.

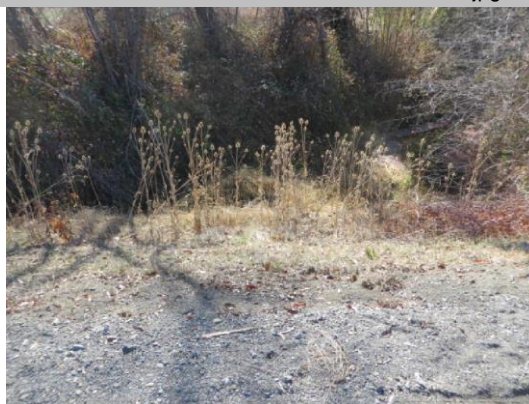
Photo 2 of 3 : UCIP_SP_2018_26888_49665.jpg

Outlet visible at concrete headwall on LS toe.

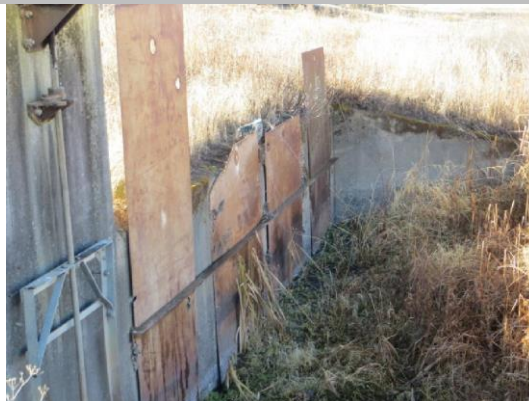
Photo 3 of 3 : UCIP_SP_2018_26888_49664.jpg

FS_ID:26888
DS_ID:21233
EP_NO: 11507
Repair Type: Non-Urgent
Crossing Status: Found
UCIP Comments: 10/27/2017 This structure is inspected annually under the Structure and Channel Summer Inspection (part of the Levee Inspection Program) conducted by the DWR Flood Project Integrity and Inspection Branch (FPIIB). (DWR UCIP - O. Magana)
Some sediment buildup at outlet on LS toe.
FIELD_STRUCT_DESC: [Clover Creek Diversion Structure] 3 of 6: 36-inch corrugated metal drainage pipe through the levee, 12 feet below the crown. Concrete headwall on both ends. Steel slide gate plate blocks inlet on the waterside (WS) toe. (six 36-inch pipes and structure [HLM 0.3] retained under Automatic Board Order (ABO) issued as Permit No. 11507, 1975 - Lake County Flood Control and Water Conservation District). [Additional Reference(s): DWR Levee Log, 2005. USACE Sacramento O&M Manual 506, Part 2, August 1961, (HLM 0.31)].

Steel slide gate visible at concrete headwall on WS toe.

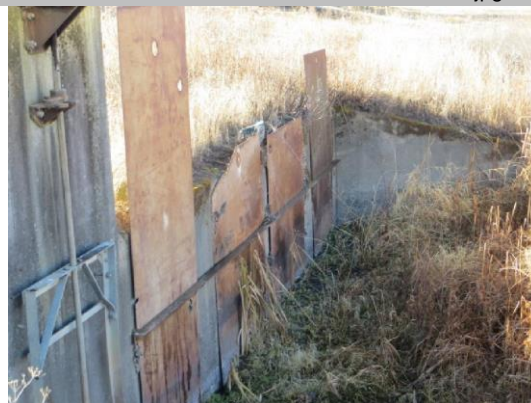
Photo 3 of 3 : UCIP_SP_2018_26885_49632.jpg

FS_ID:26885
DS_ID:21232
EP_NO: 11507
Repair Type: Non-Urgent
Crossing Status: Found
UCIP Comments: 10/27/2017 This structure is inspected annually under the Structure and Channel Summer Inspection (part of the Levee Inspection Program) conducted by the DWR Flood Project Integrity and Inspection Branch (FPIIB). (DWR UCIP - O. Magana)
Some sediment buildup at outlet on LS toe.
FIELD_STRUCT_DESC: [Clover Creek Diversion Structure] 4 of 6: 36-inch corrugated metal drainage pipe through the levee, 12 feet below the crown. Concrete headwall on both ends. (six 36-inch pipes and structure [HLM 0.3] retained under Automatic Board Order (ABO) issued as Permit No. 11507, 1975 - Lake County Flood Control and Water Conservation District). [Additional Reference(s): DWR Levee Log, 2005. USACE Sacramento O&M Manual 506, Part 2, August 1961, (HLM 0.31)].
FS Date: 1/9/2014

Steel plate slide gate visible at headwall on WS toe.

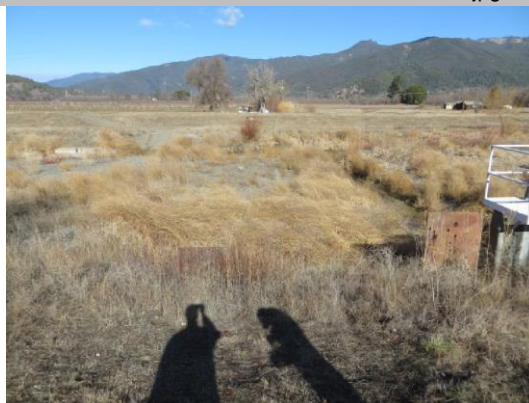
Photo 1 of 3 : UCIP_SP_2018_26877_49610.jpg

FS_ID:26877
DS_ID:21229
EP_NO: 11507
Repair Type: Non-Urgent
Crossing Status: Found
UCIP Comments: 10/27/2017 This structure is inspected annually under the Structure and Channel Summer Inspection (part of the Levee Inspection Program) conducted by the DWR Flood Project Integrity and Inspection Branch (FPIIB). (DWR UCIP - O. Magana)
Some sediment buildup at outlet on LS toe.
FIELD_STRUCT_DESC: [Clover Creek Diversion Structure] 6 of 6: 36-inch corrugated metal drainage pipe through the levee, 12 feet below the crown. Concrete headwall on both ends. Steel slide gate covers waterside (WS) inlet. (six 36-inch pipes and structure [HLM 0.3] retained under Automatic Board Order (ABO) issued as Permit No. 11507, 1975 - Lake County Flood Control and Water Conservation District). [Additional Reference(s): DWR Levee Log, 2005. USACE Sacramento O&M Manual 506, Part 2, August 1961, (HLM 0.31)].
FS Date: 1/9/2014

Steel slide gate visible at headwall on WS toe.

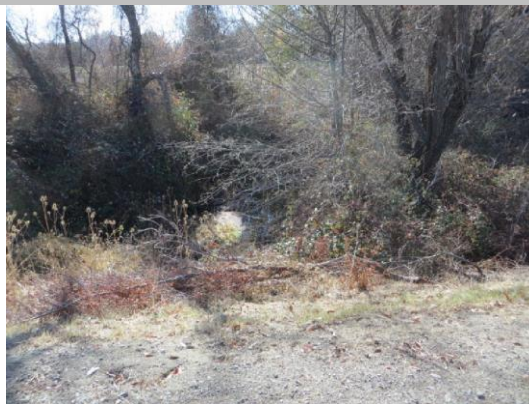
Photo 2 of 3 : UCIP_SP_2018_26877_49609.jpg

Concrete headwall on LS toe.

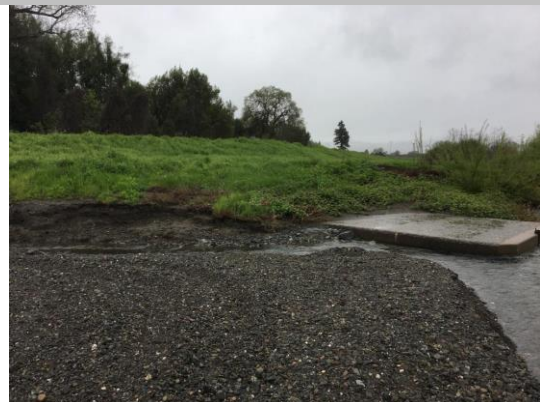
Photo 1 of 3 : LEVAL_SP_2018_19_352.jpg

Levee Evaluation Comments
Description:
Site ID No:19
Site Designation:LCWPD-01
Repair Type: Erosion
Rating:Area of Concern
Field Date:6/5/2017
Notes: Erosion exists between a small weir and diversion pipes.
